Austin Parks and Recreation Department
Barton Springs Pool Gravel Bar Removal 2011
Update

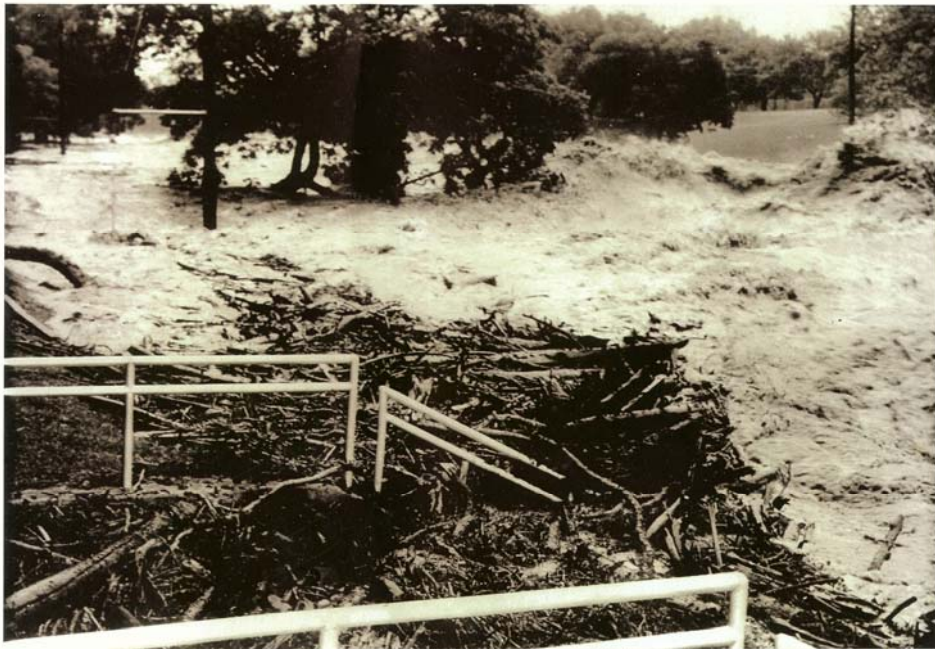
Picture #1

Barton Springs has experienced many floods through the years. (See photographs 1-3) The smaller floods tend to deposit silt and small flood debris in the pool while the larger floods deposit flood debris that includes gravel and rocks. In 1998 and again in 2000, Barton Springs experienced floods which deposited material in the pool of such a great magnitude that it formed a thick gravel bar in the deep end of the pool, making the water roughly five feet deep.

Picturesque and peaceful Barton Springs was turned into a raging torrent that left debris and destruction after this flood rolled in on the morning of June 17, 1958. This flood was a "good-un," but some floods have circled the bathhouse. [AUSTIN HISTORY CENTER - PICA 22648]

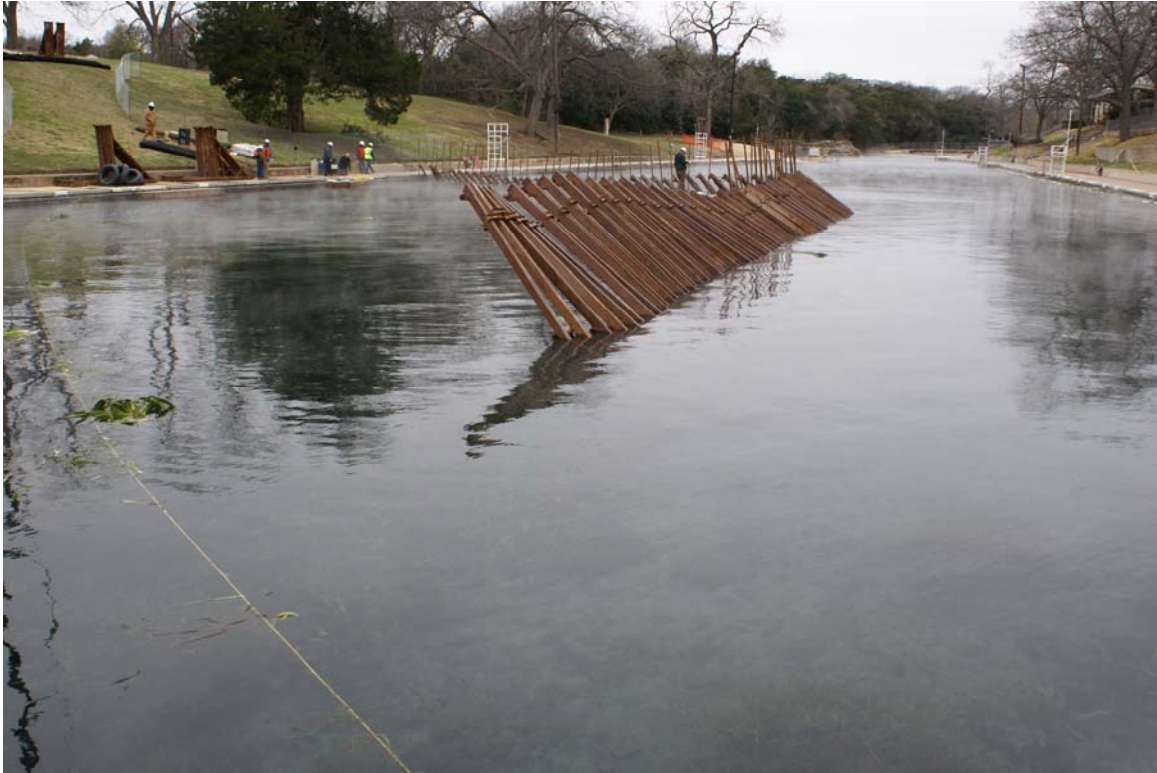
Picture #5

Overall, this project was successful at removing most of the gravel bar as planned, however there was one concern that resulted in a reduction of the amount of debris removed. The original plan anticipated being able to remove debris closer to the northern edge of the pool deck, but in order to keep the cofferdam stable, gravel was not removed within twelve feet of the inner edge of the frames; the limit of gravel removed was twelve feet further south, toward the middle of the pool. (See photograph 5)

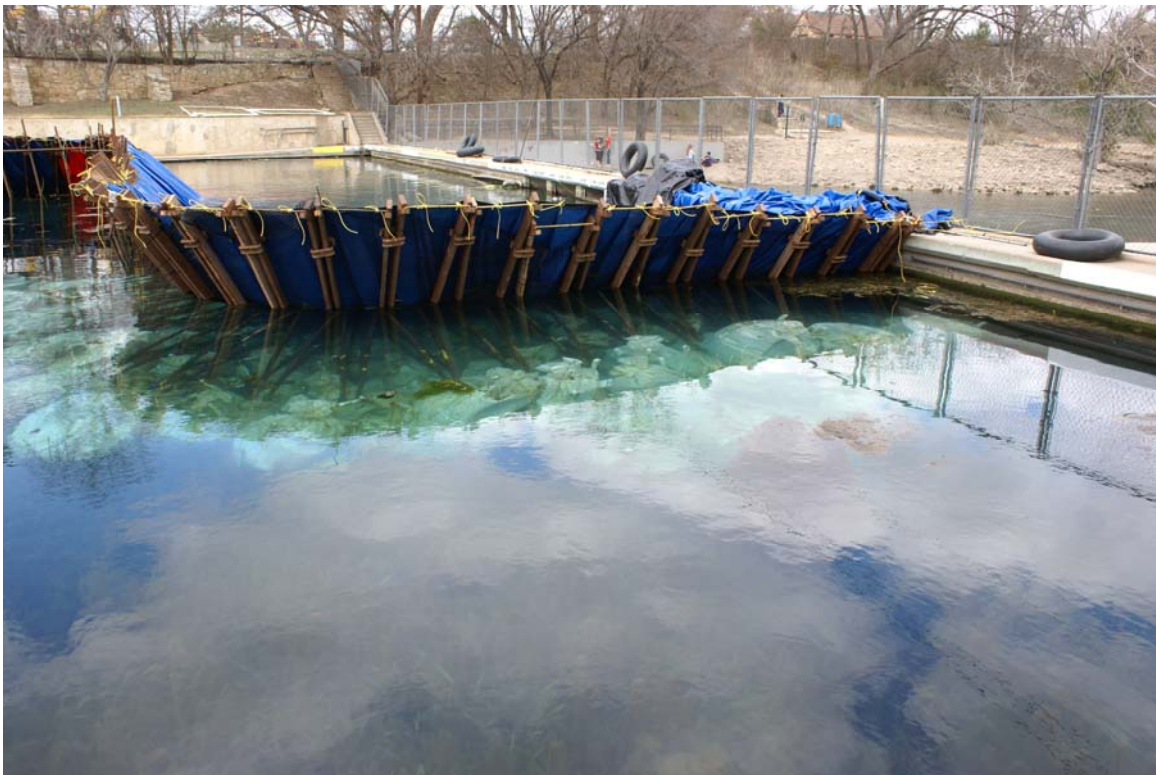
Picture #8

Another challenge was the lack of availability of a twelve foot cofferdam needed to dewater the deepest area, located near the pool's dam. To cross the deep area, the cofferdam was constructed on top of "Super Sacks" to increase its height. These plastic and mesh sand filled sacks measure 3' x 3' x 3' and weigh 1 ton. (See photographs 8 & 10)

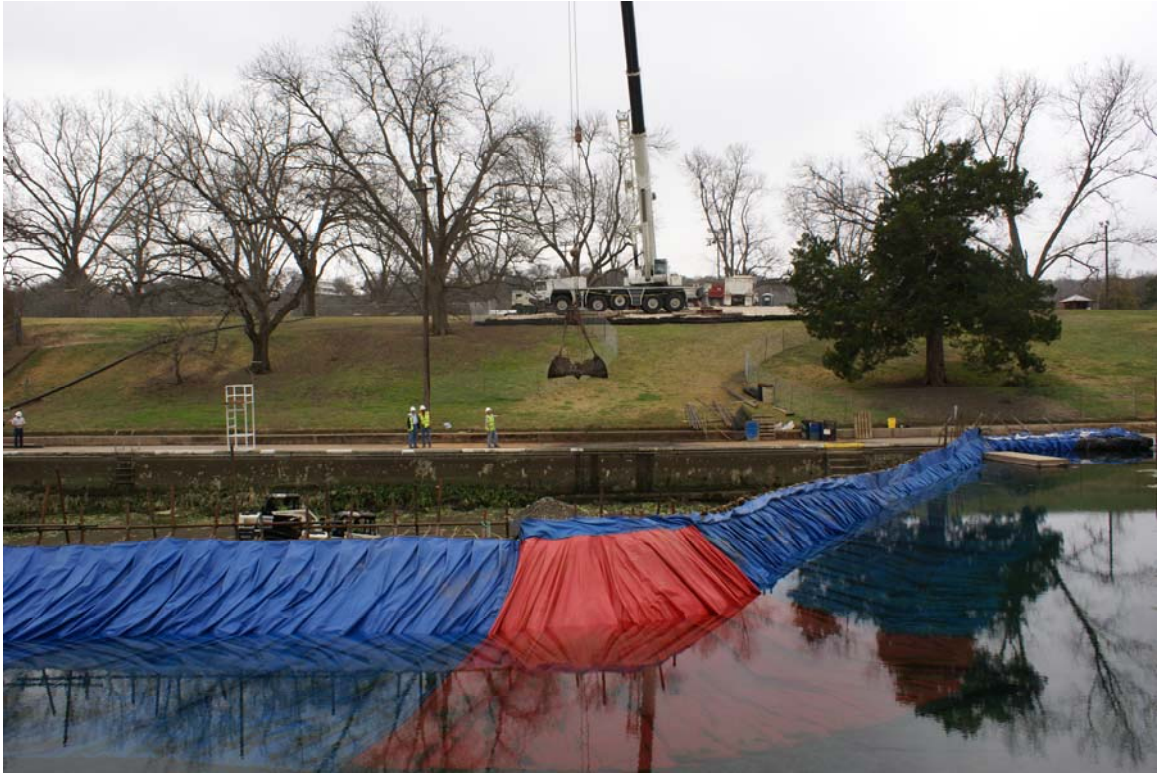
Picture #9

In 2009, Weston Solutions was hired to develop a system to remove the remaining gravel bar. Weston Solutions worked with PARD, WPD and the community to develop a plan that they thought would best meet current needs. Due the sensitivity of the area, a plan was developed that used a crane situated on the south lawn to remove the remaining portion of the flood debris. A temporary pad was placed on the south hill to provide a stable foundation for the crane and a temporary road was installed to facilitate removal of material. A cofferdam was constructed around the gravel bar. (See photographs 4-10) This area was dewatered and the crane lifted front end loaders onto the pool's bottom. (See photographs 11-12) The front-end loaders placed the gravel into piles and the crane's clamshell lifted the gravel into dump trucks. (See photographs 9 & 12)

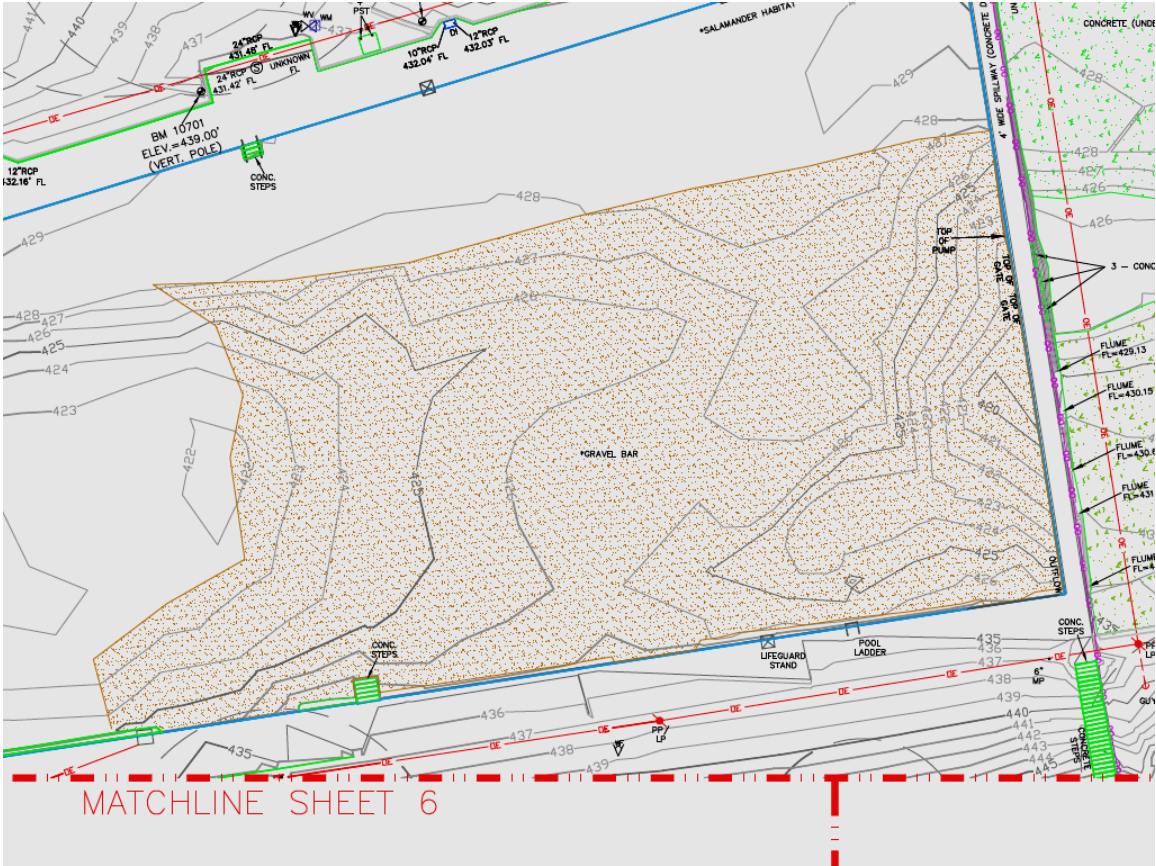
Picture #13

Six-hundred and one tons, approximately six-hundred cubic yards, of material was removed from the dewatered area during the period of January 24, to March 11, 2011. As planned and requested by concerned citizens, at least one foot of gravel was left on the bottom for plants to take root and grow. Watershed Protection staff is currently working to acquire surveying services to determine the new elevation of the gravel substrate overlying the pool bottom. The bottom elevation prior to gravel removal is shown on the attached topographic sheets. (See photographs 13-14)
